SAFETY INVESTIGATION REPORT

**HELLENIC AIR FORCE F-16D BLK 50
S/N 93-1084 341SQ/111CW**

**ALBACETE AFB (ESP), ALBACETE
26 JANUARY 2015**

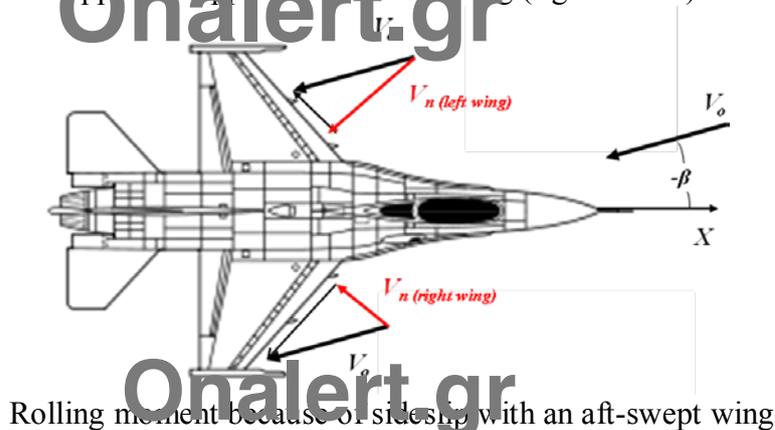
The movement of the MA's nose to the right during the sideslip produced an aerodynamic right wing down rolling moment. The recorded roll was approximately 7° at the first second following WOW and increased dramatically to approximately 33° in the following second. The roll continued increasing bank until the MA impacted the ground. The main causes of the rolling moment were as follows:

-The F-16 is equipped with an aft-swept wing. In all aft-swept wing A/C, during sideslip, the upwind wing toward the velocity vector (left in MA) produces more lift than the downwind wing as the normal vector of the velocity (the one perpendicular to the leading edge of each wing – V_n (left wing)) is increasing. The "spanwise" vector of the velocity produces no lift. The opposite happens to the other wing (right in MA).

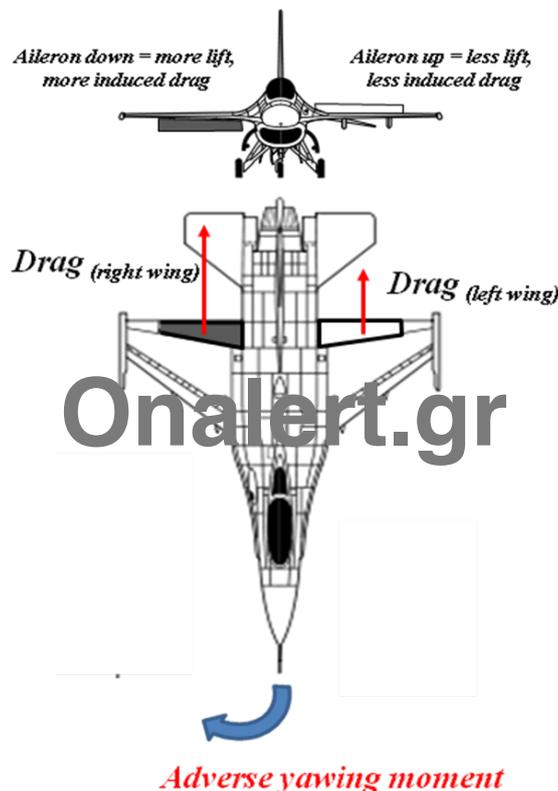
Adverse yawing moment due to aileron deflection

Although the right roll moment was decreased approximately at 2.5 sec after WOW (from approximately 22 degrees/second to 6.6 degrees/second), left control stick inputs were insufficient to cease the right roll. Due to the MA lack of desired response, PIC increased the left control stick command. At 2.6 seconds following WOW (32:30.88), the maximum value (which is the maximum available) left roll stick input was recorded (-22 pounds)⁵. This left roll control stick input, without ARI activation (no automatic rudder to offset adverse sideslip due to roll surface deflection(s)), exacerbated the right sideslip due to increased drag generation from the wing. The result was additional MA's yaw to the right (adverse yaw). Additive to the sideslip factors were the asymmetric store on right wing and the 9 knot wind from 330° (60° right from the nose).
